Assessing Sedimentation Issues within Aging Flood Control Dams, Oklahoma

By Sean J. Bennett and Charles M. Cooper

Research Report No. 15

A preliminary report prepared for the USDA-NRCS, Stillwater, OK

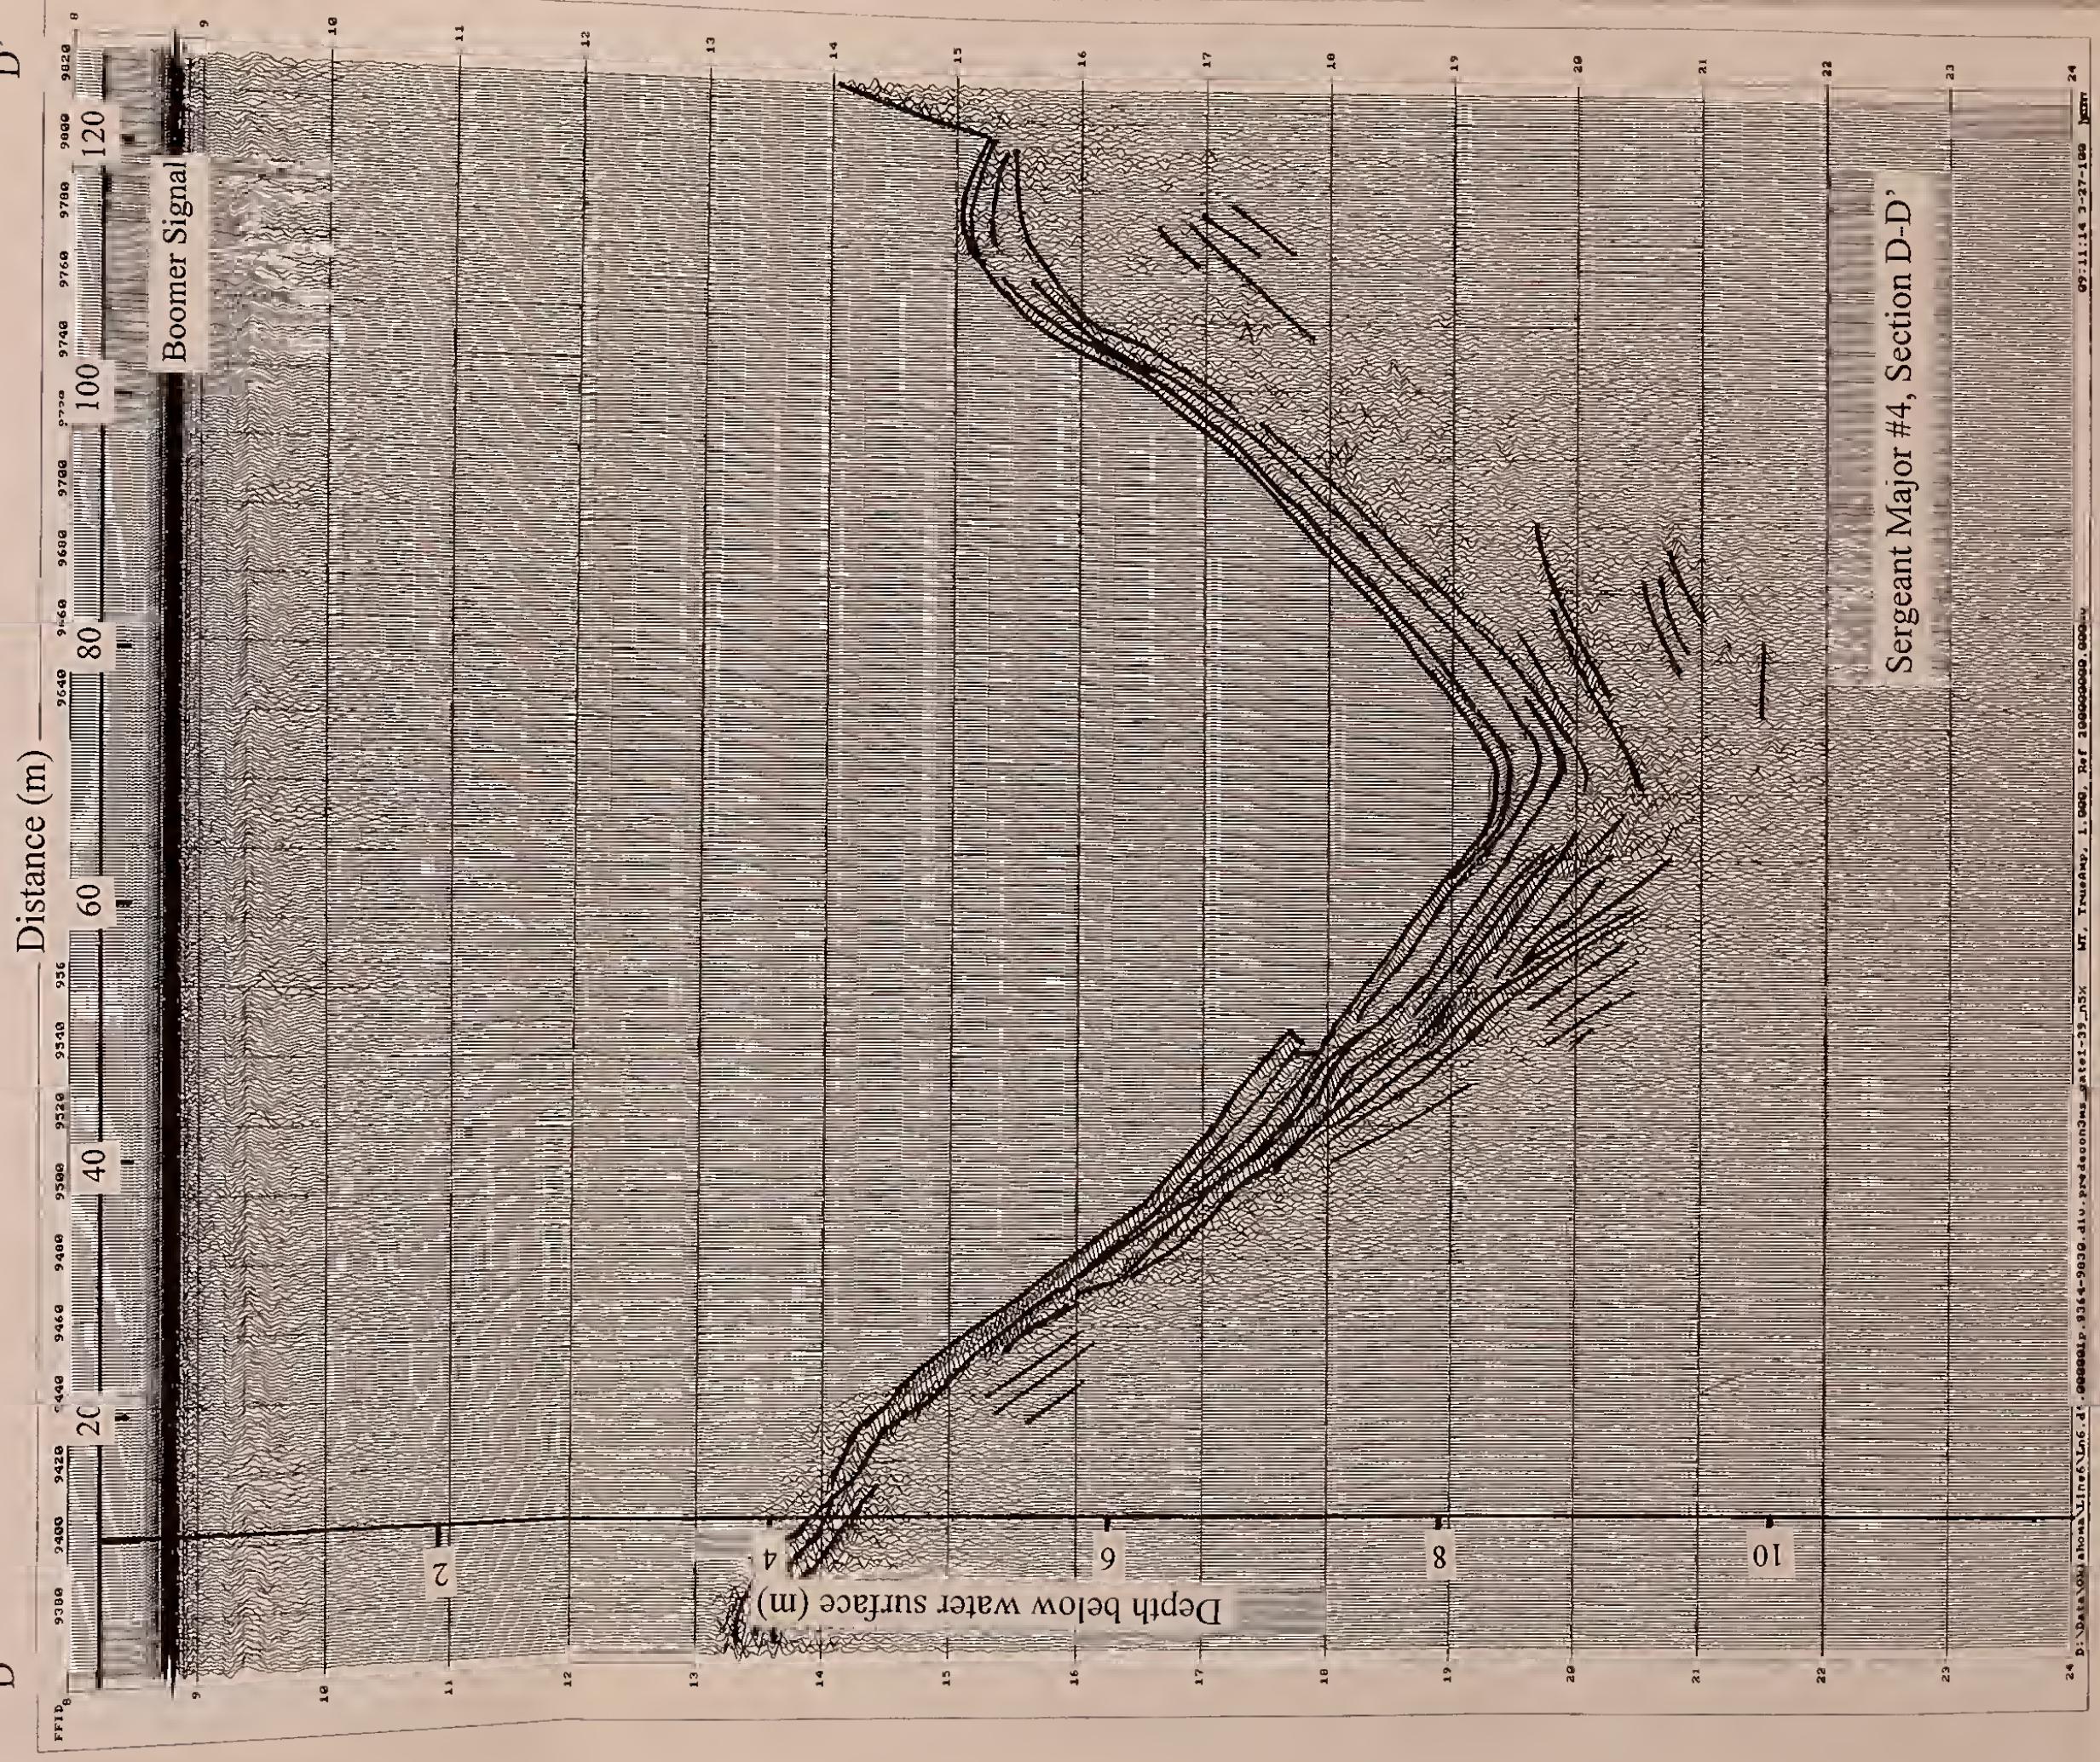
The seismic line parallel to the embankment (section D-D'; Figure 3-17) shows several reflectors that parallel the subsurface topography. These reflectors range in thickness from 0.1 to 0.2 m, and are observed to depths of about 1.5 m. Several of these reflectors are continuous for up to 80 m across the basin, while others show very short lateral extents.

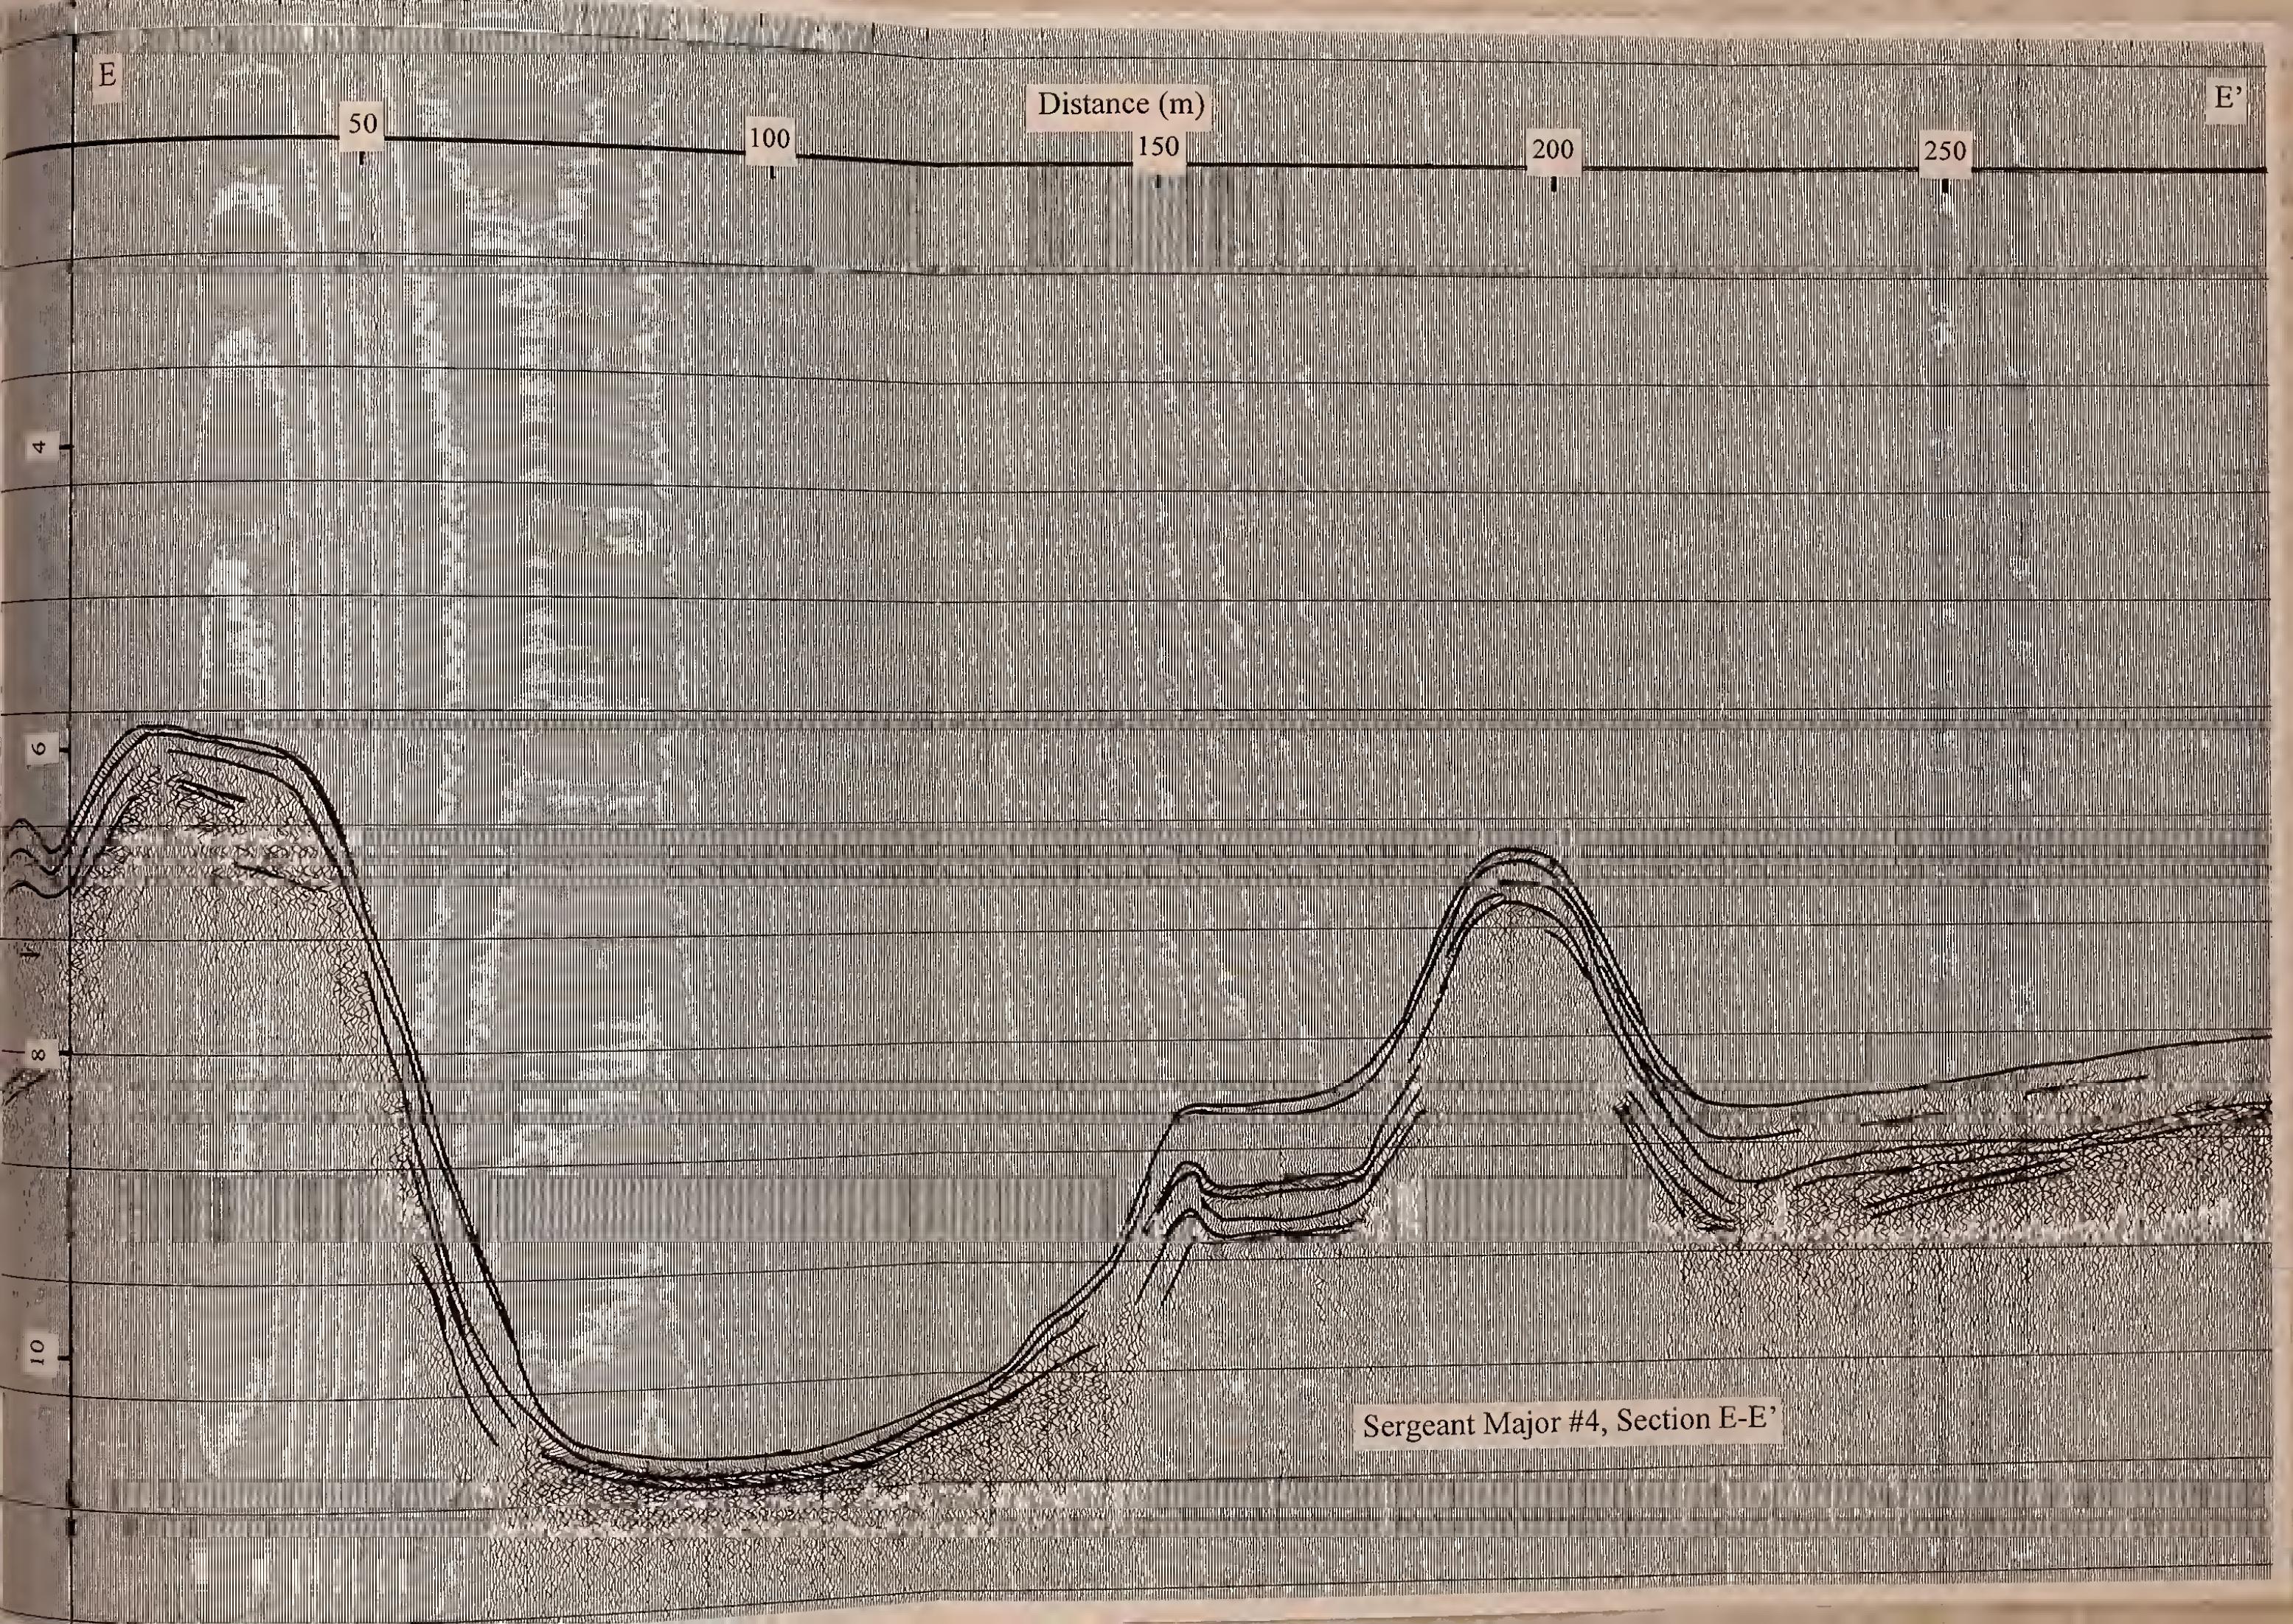
Sergeant Major #4, Section D-D'

The seismic line through the central part of the reservoir (section E-E'; Figure 3-18) also displays numerous reflectors ranging in thickness from 0.1 to 0.5 m. These reflectors drape the existing reservoir bathymetry and are restricted in depth to about 1 m. The reflectors appear to thicken towards the southeast (towards E'), away from the center of the basin.
